# Guidelines for **managing asbestos related health and safety risks** at work

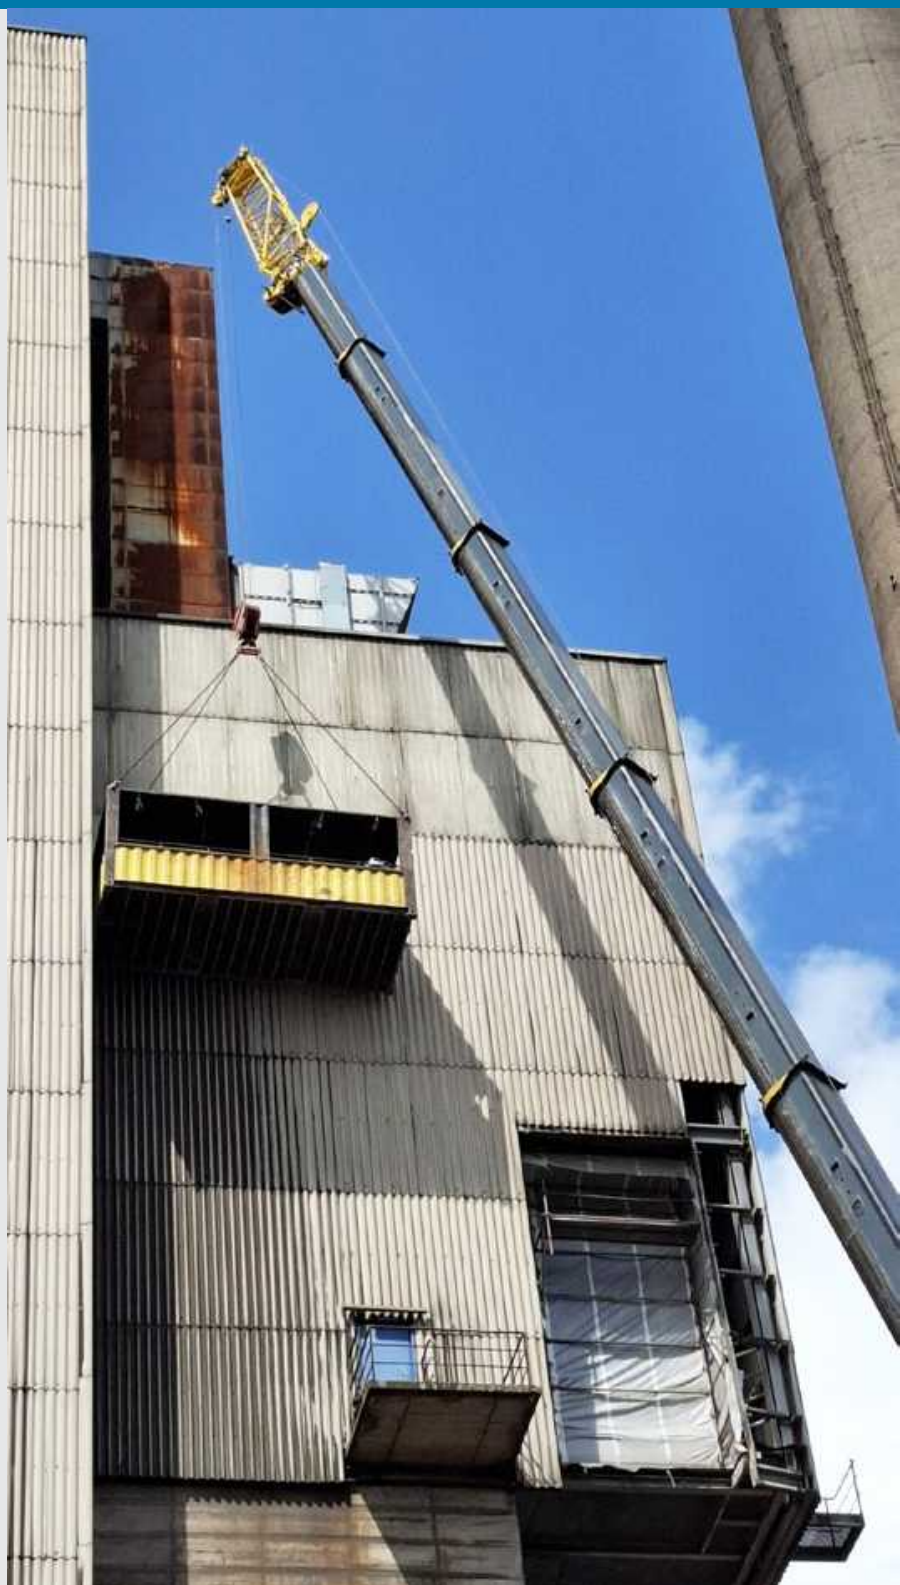
**Figure 4-2: Example of the risk of working at heights during the removal of asbestos plates during the demolition of a power plant in Germany**

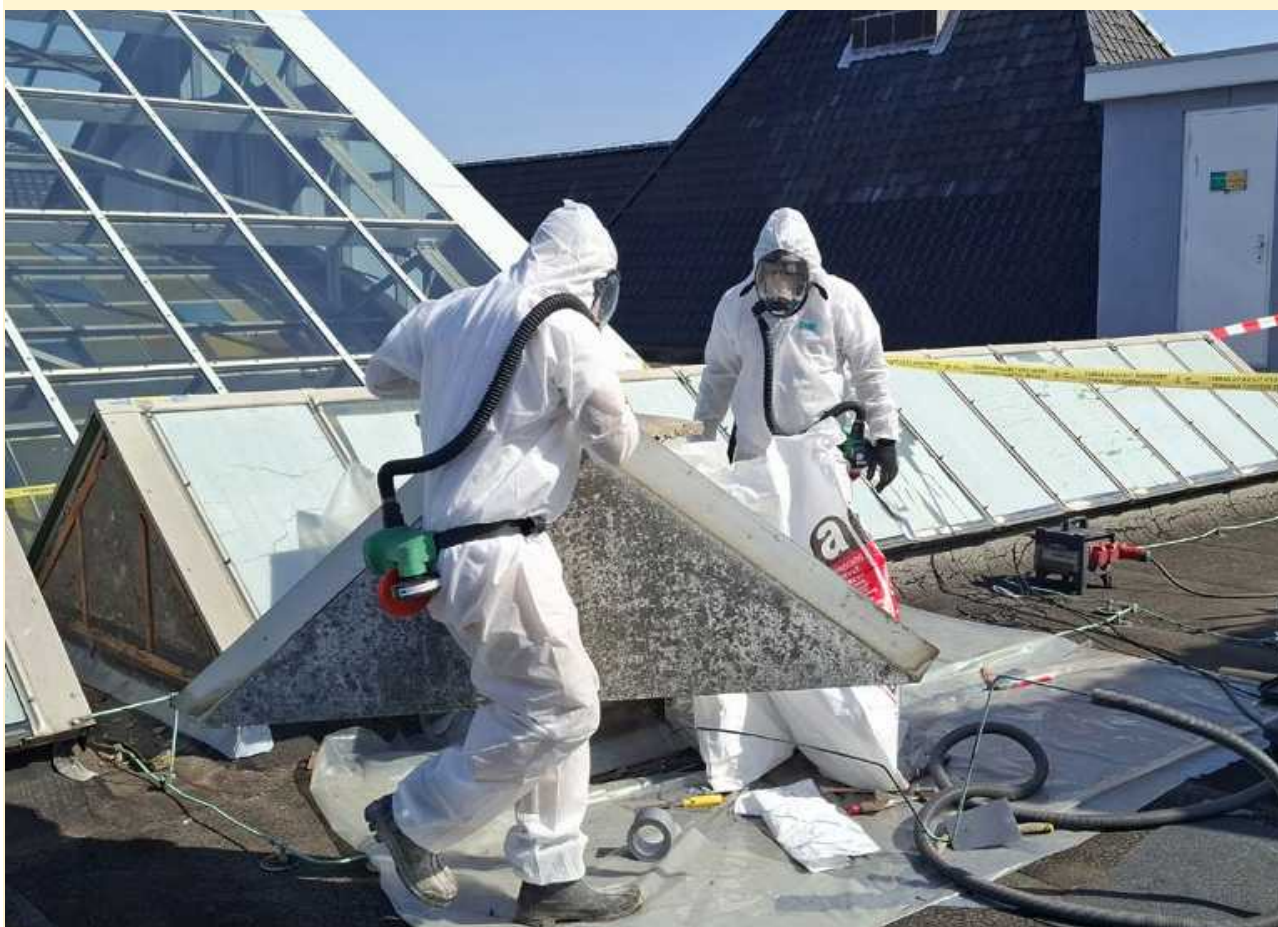
Figure 4-4: Workers removing asbestos plates on the roof

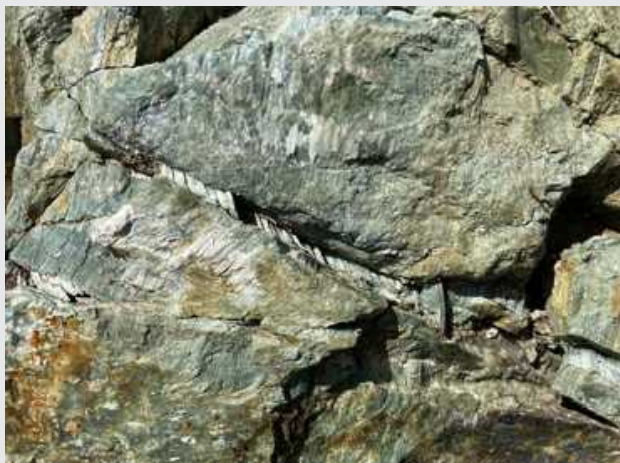
**Figure 5-4: Chrysotile cross-vein in serpentinites (France)**

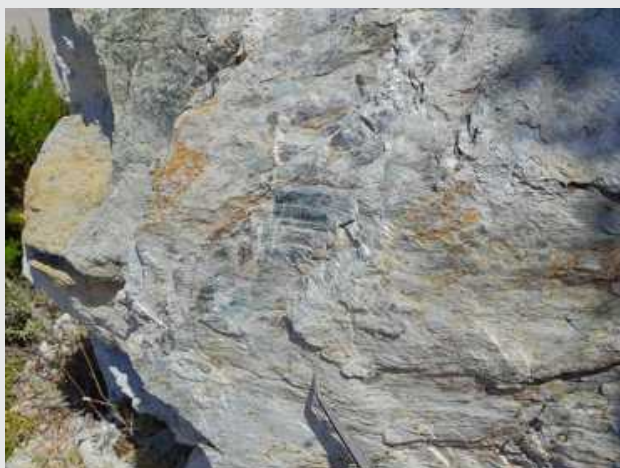
**Figure 5-5: Alumino-magnesian metagabbros with tremolite asbestos**

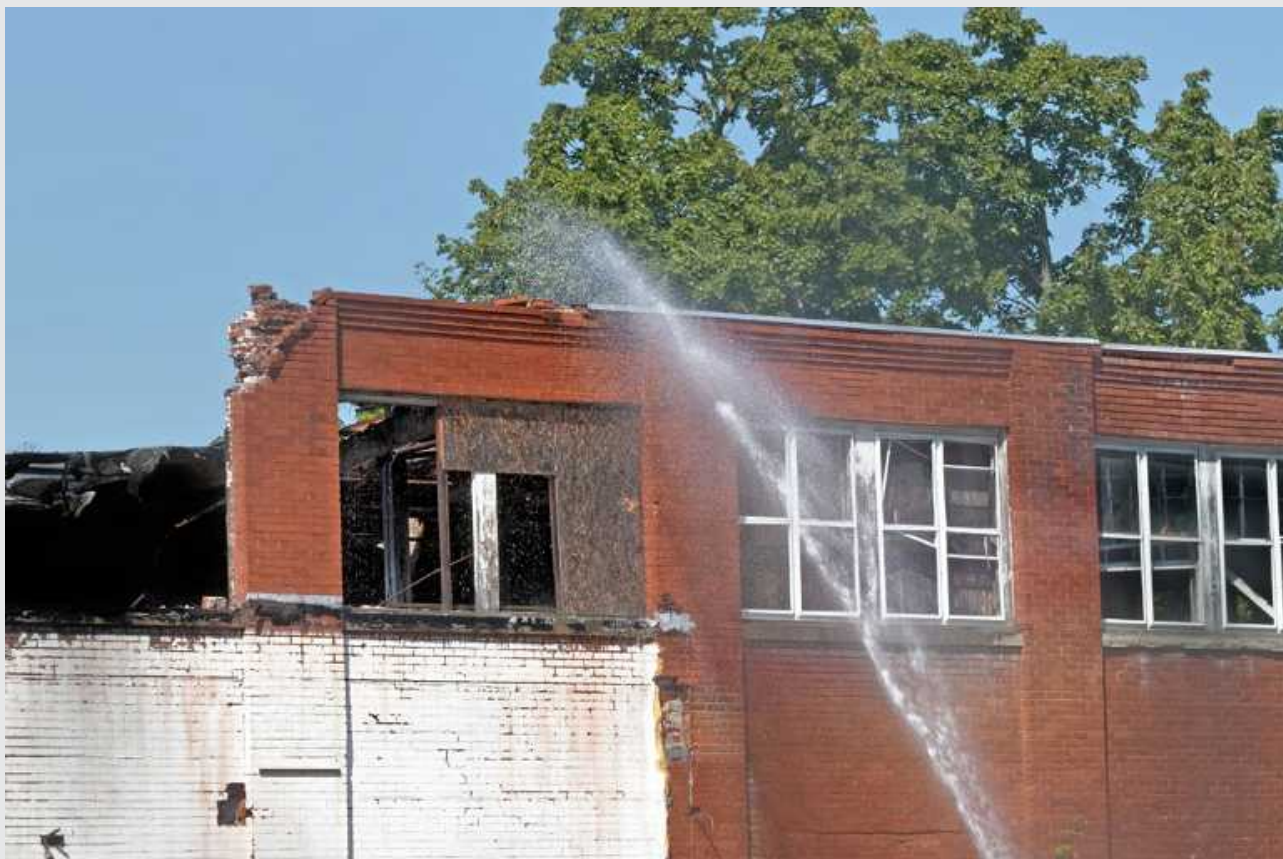
**Figure 8-1: Example of wetting a building containing asbestos**

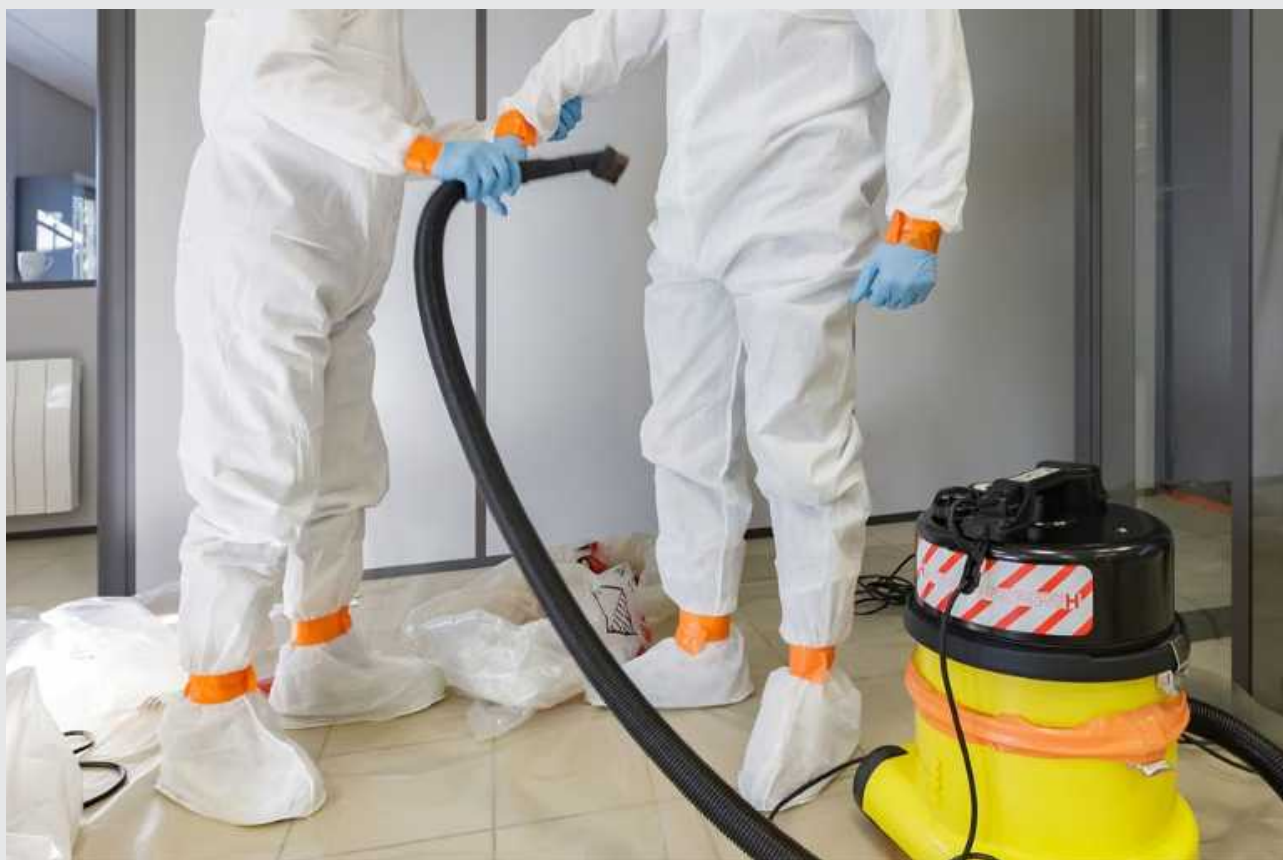
**Figure 8-6: Example of cleaning using a vacuum cleaner**

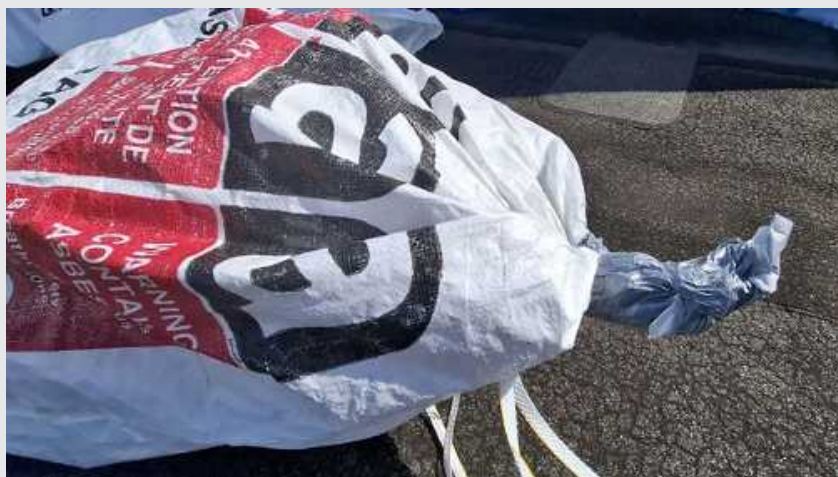
**Figure 8-7: Image of a WCA bag tied with a gooseneck closure**

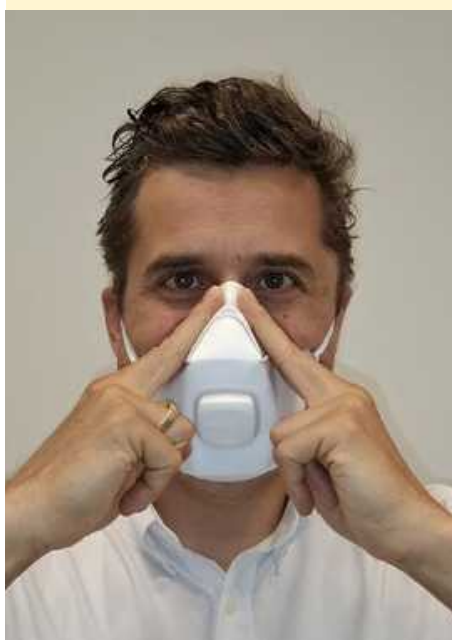
**Figure 8-10:**  
Ensuring a proper seal

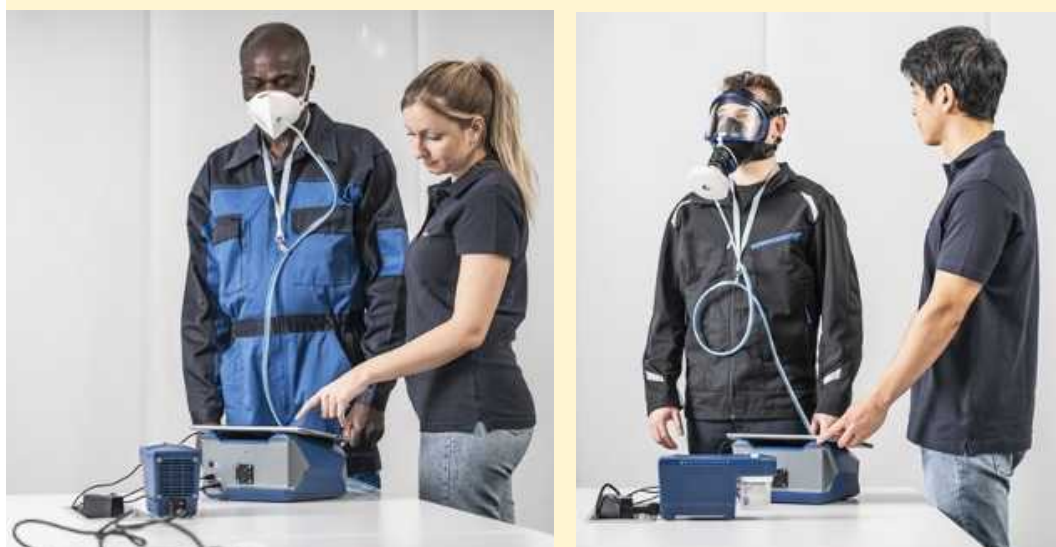
Figure 8-12: Examples of face-fit testing for full face mask and filtering facepiece

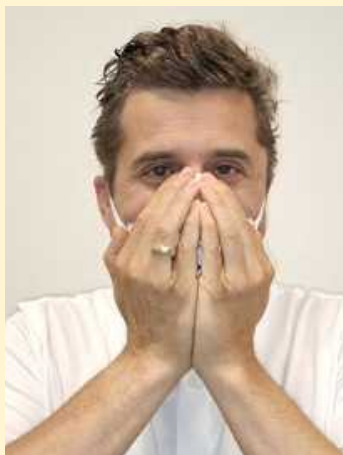
**Figure 8-13: Pre-use check for leakages for an FFP3 mask**

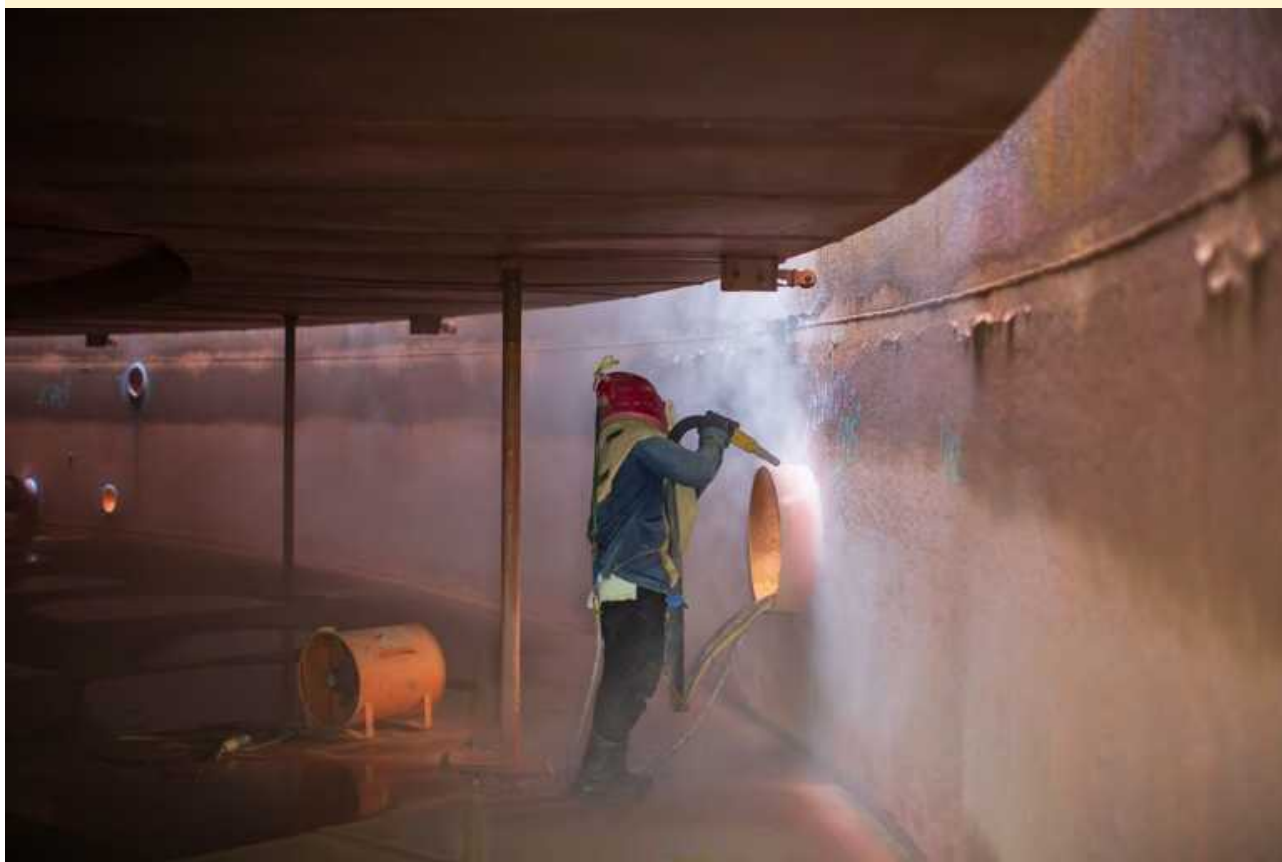
Figure 11-1: Worker removing paint inside of a fuel storage tank using blasting grit

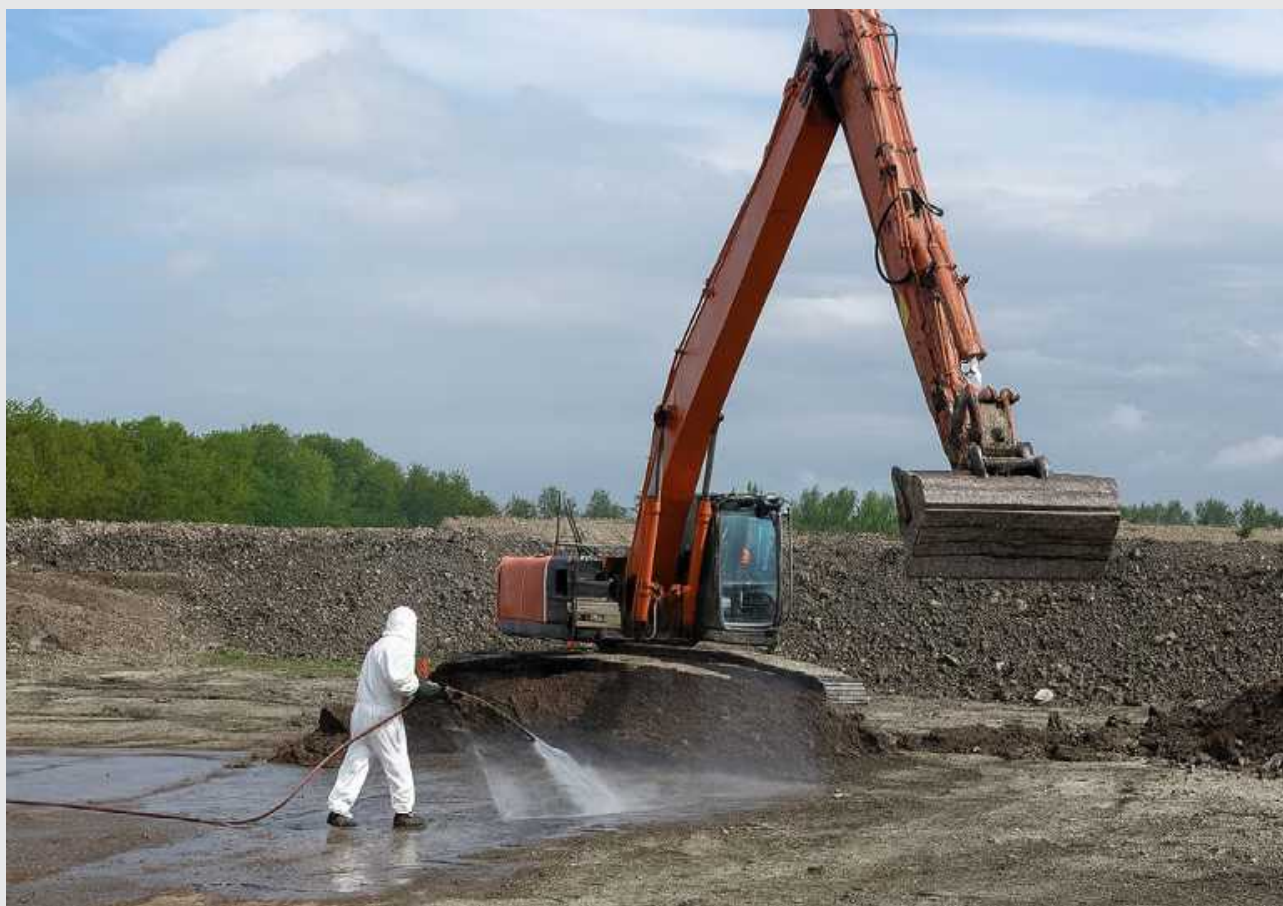
Figure 12-2: Wetting of WCA to prevent dust

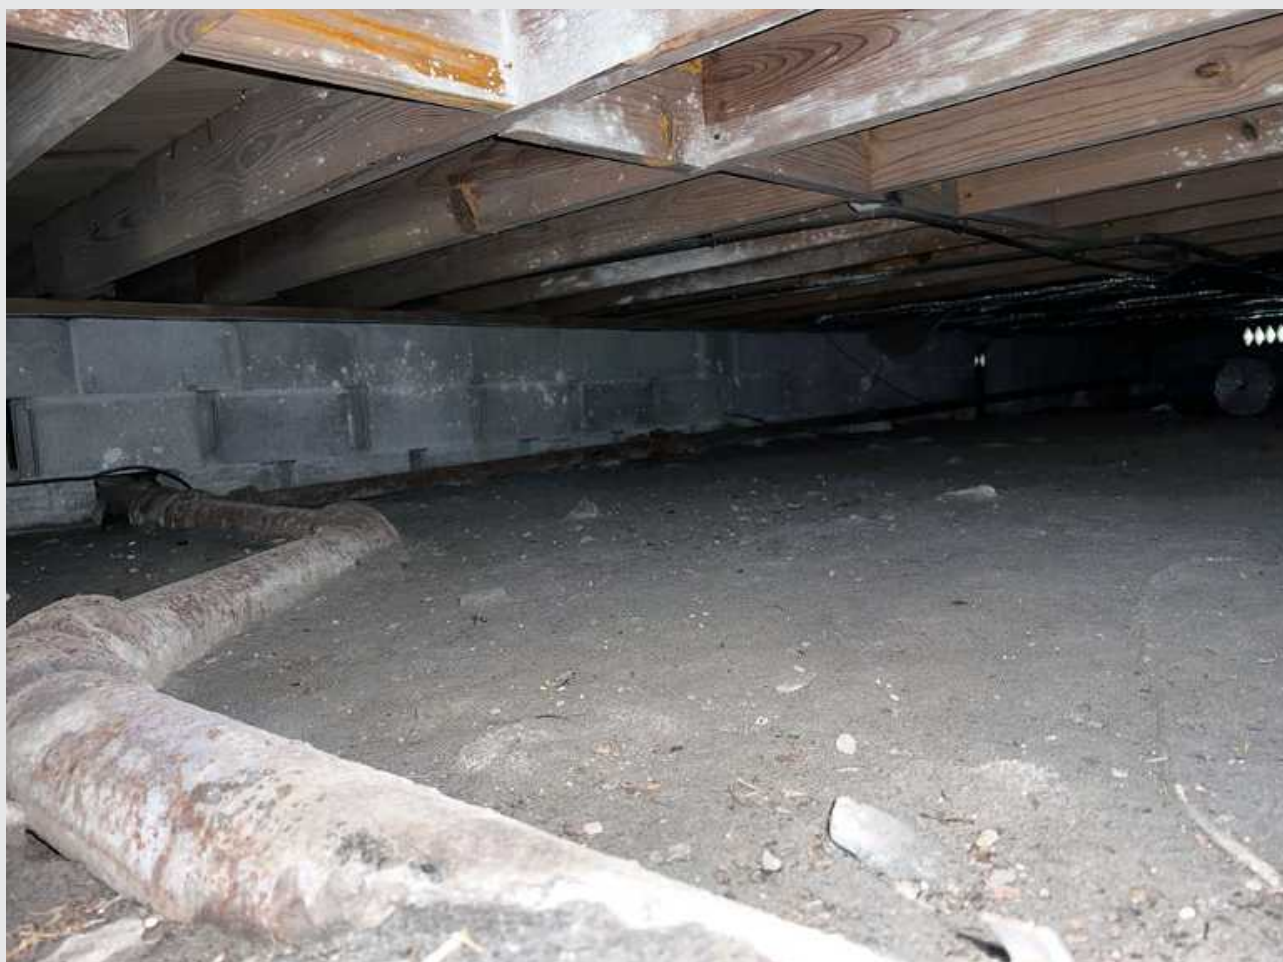
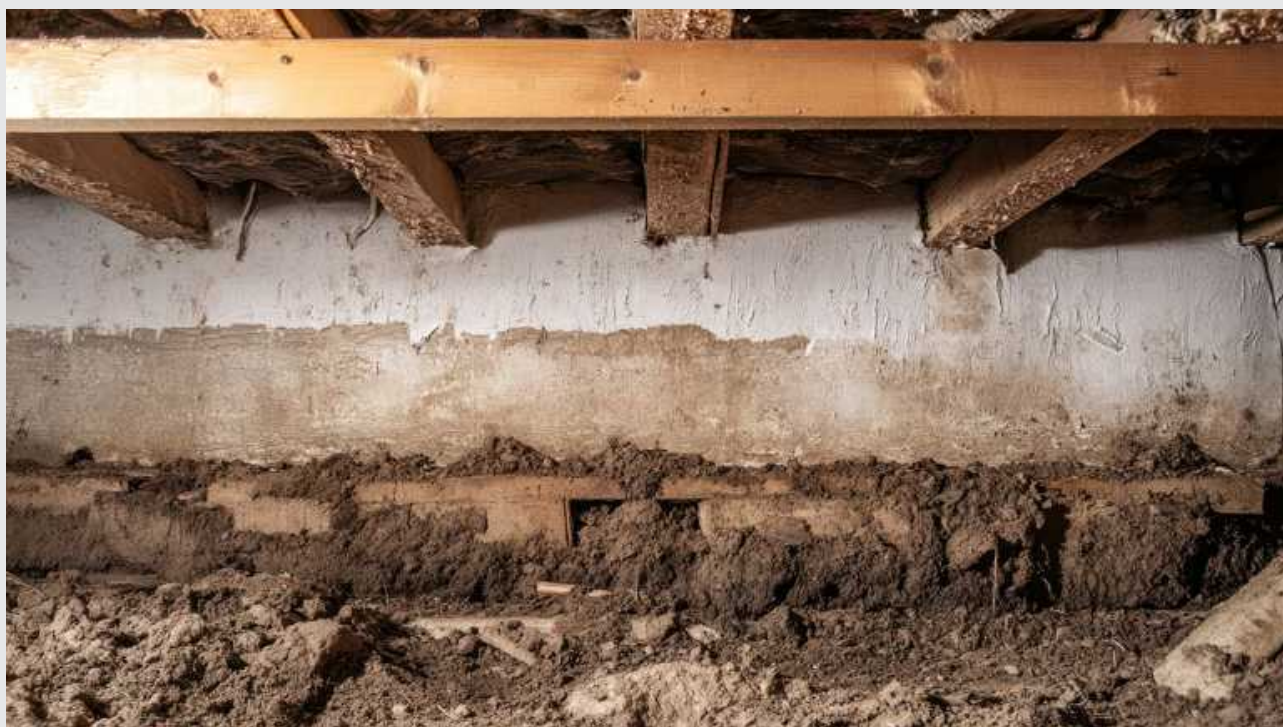
Figure 13-3: Work in crawl spaces

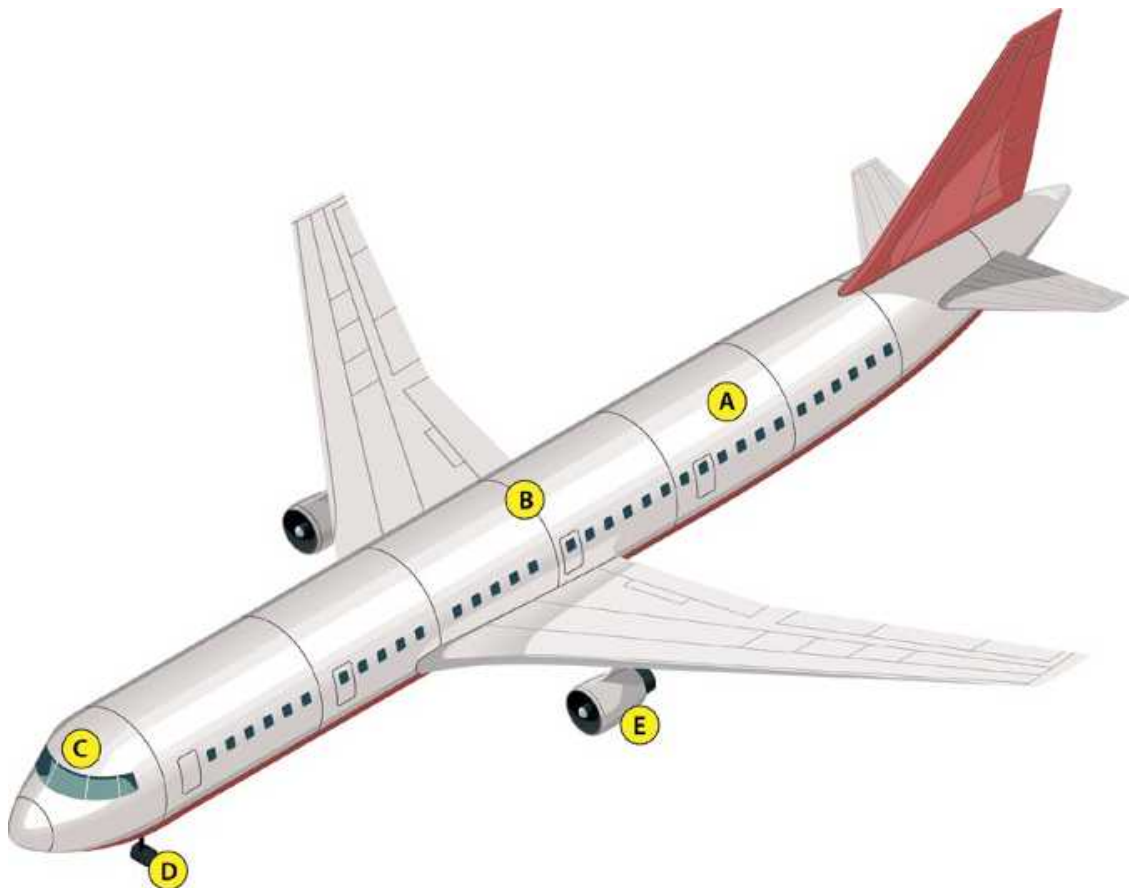
Figure 14-5: Aircraft – where asbestos might be found (non-exhaustive)

#### A: Fuselage

#### B: Air conditioning

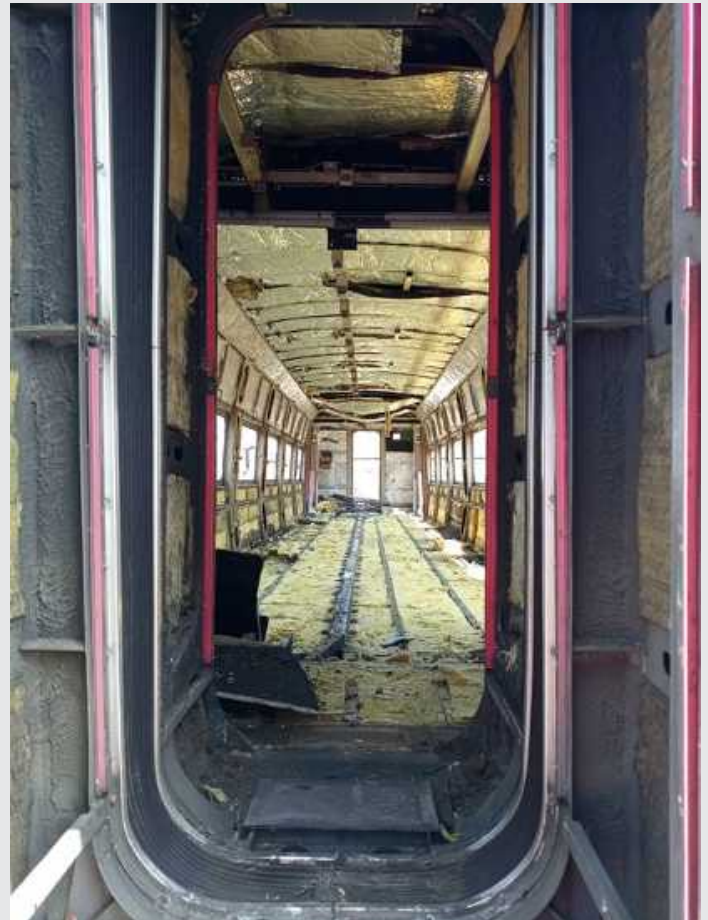
**Figure 14-7: Train carriage following the removal of non-hazardous components, awaiting asbestos removal at a train dismantling facility in France**

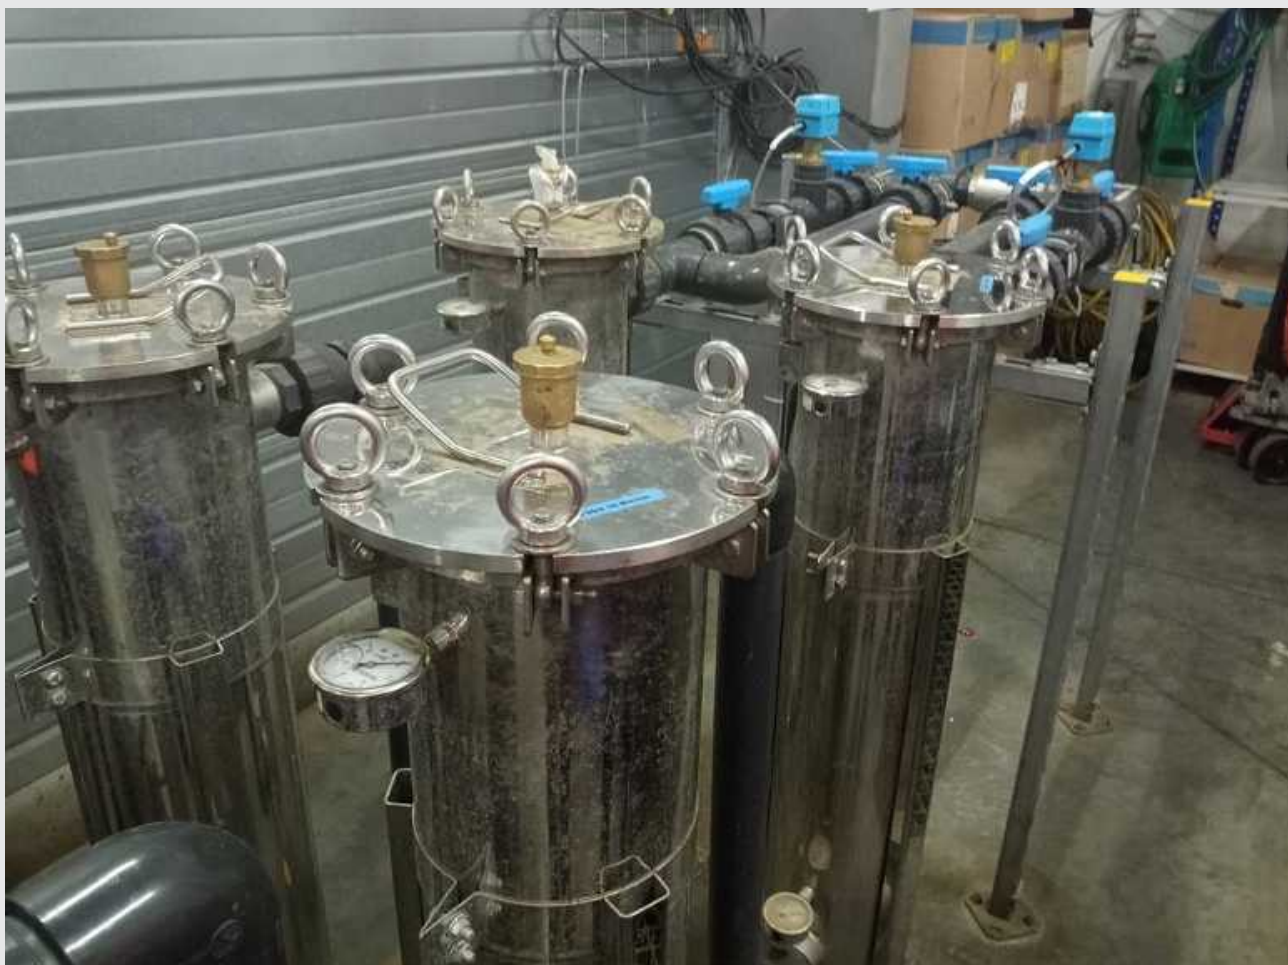
**Figure 14-9: Filters to remove asbestos fibres from waste water at a train dismantling facility in France**

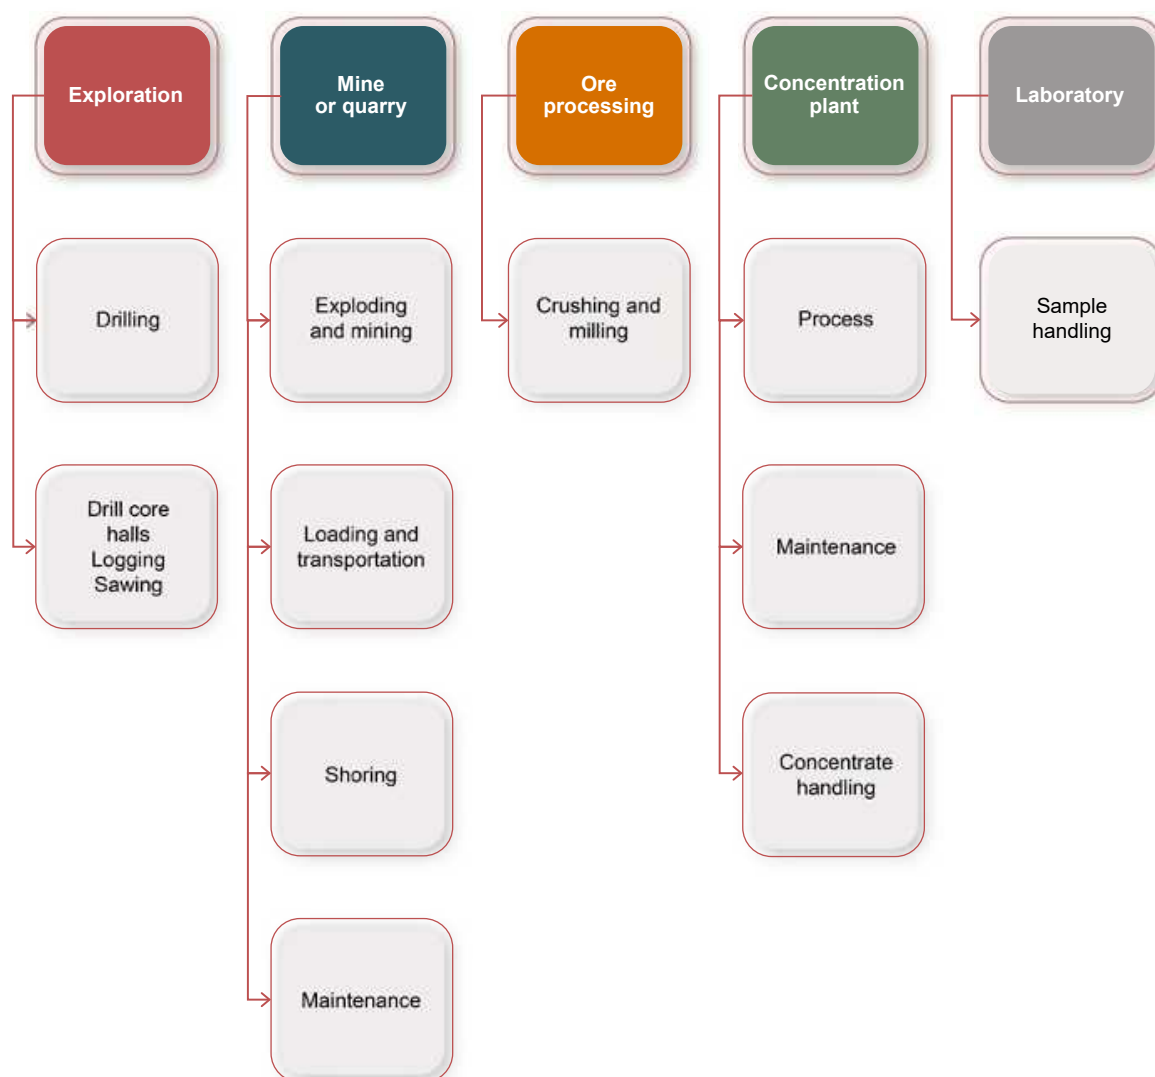
Figure 15-2: Division of mining or quarrying operations into measurement compartments and areas

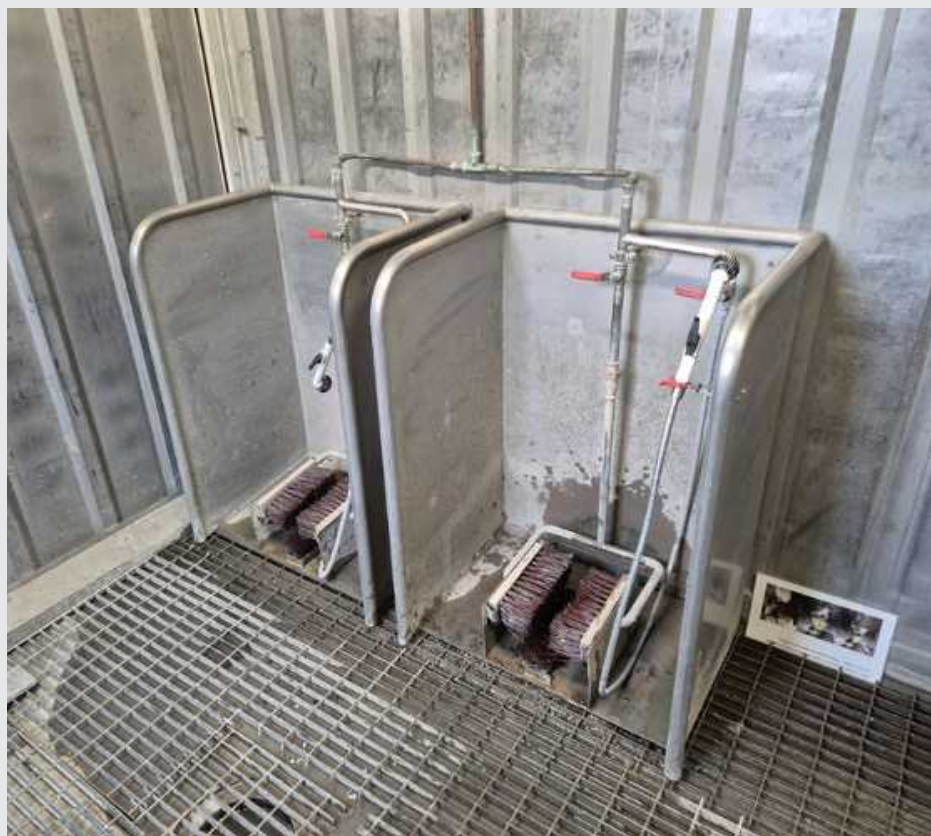
**Figure 15-3: Footwear washing facilities inside a decontamination chamber**

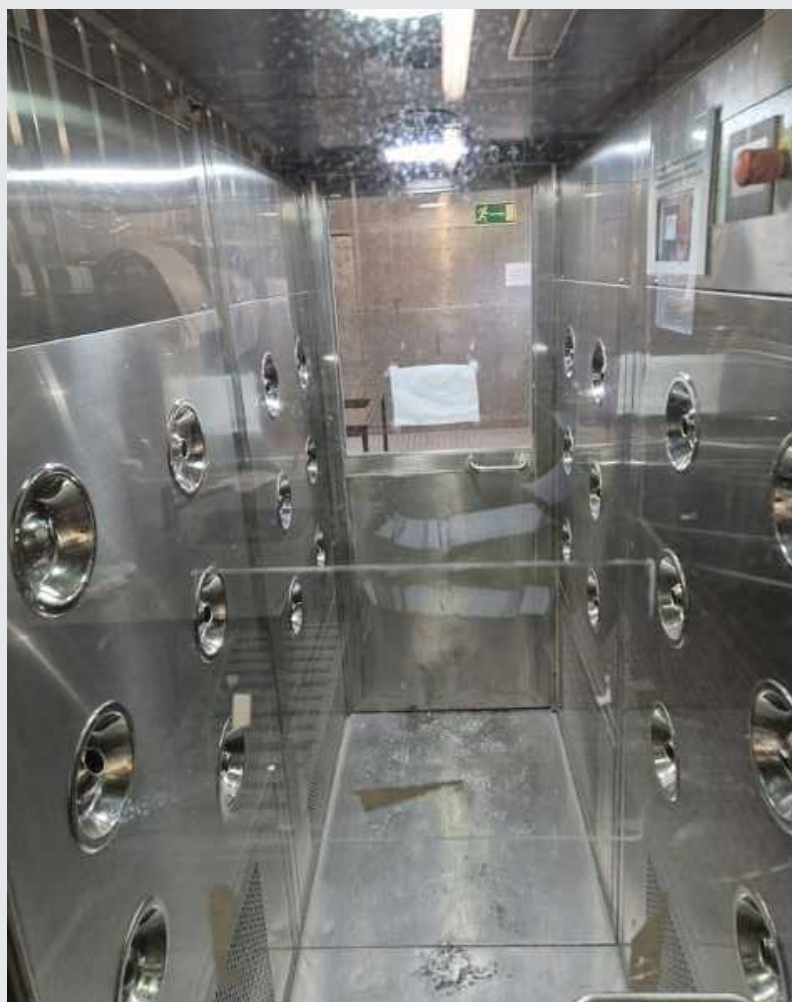
**Figure 15-4: In a decontamination chamber, air jets can be used in an air lock to remove any remaining dust from PPE after vacuuming, by circulating air downwards**

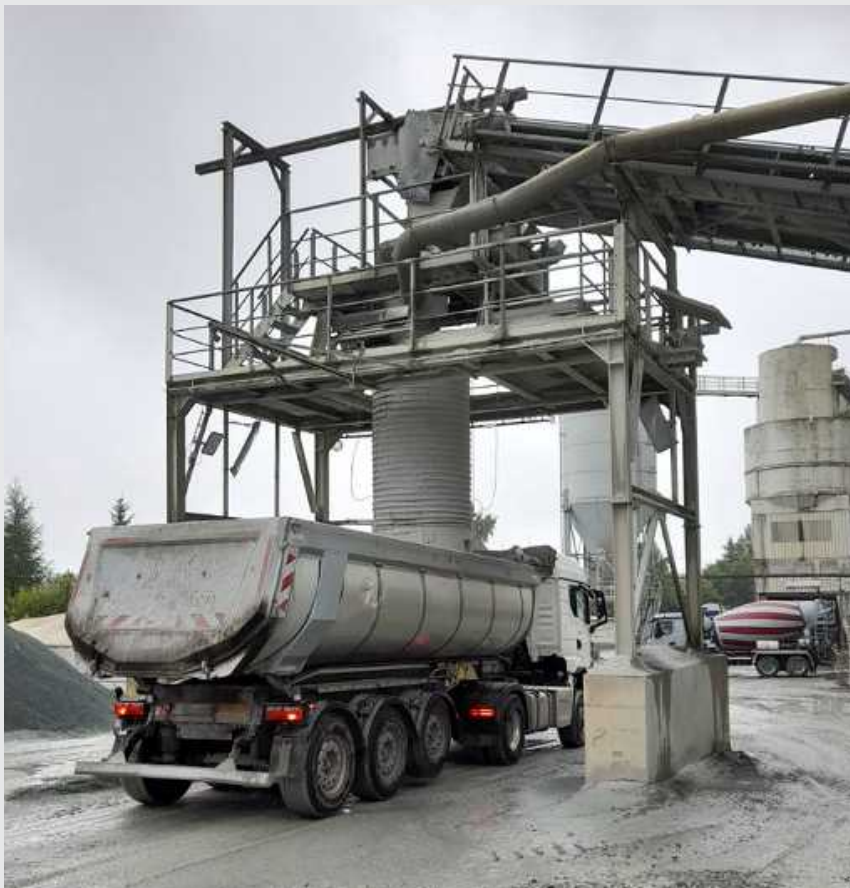
**Figure 15-5: Height-adjustable truck-loading spout with dustproof skirt**

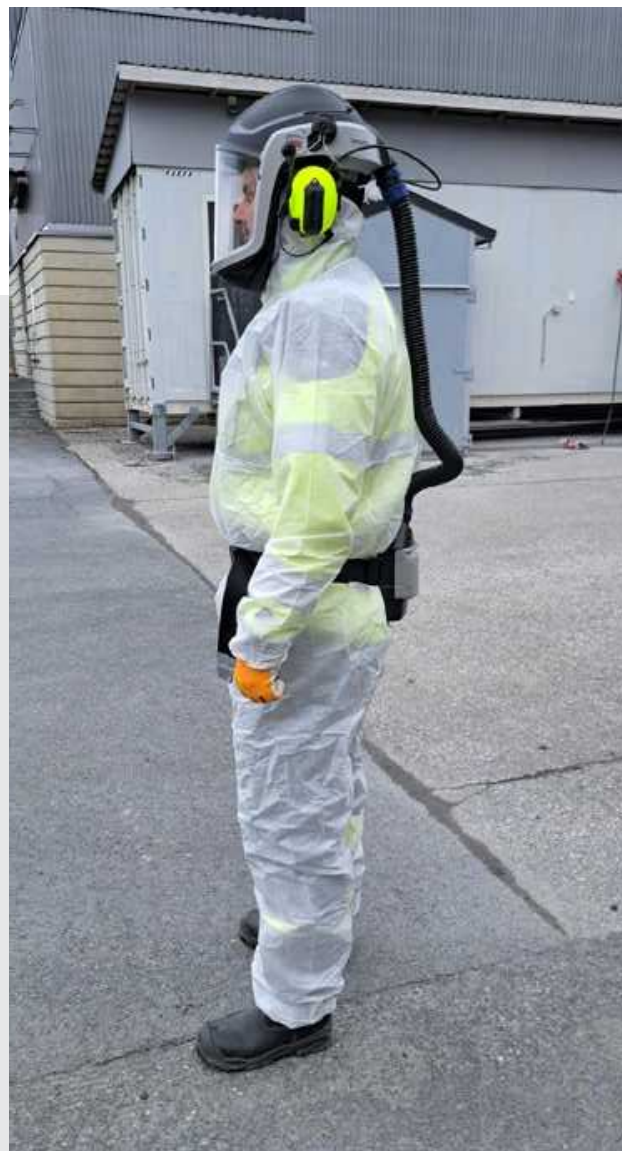
**Figure 15-7: PPE for a mine worker, including an RPD**

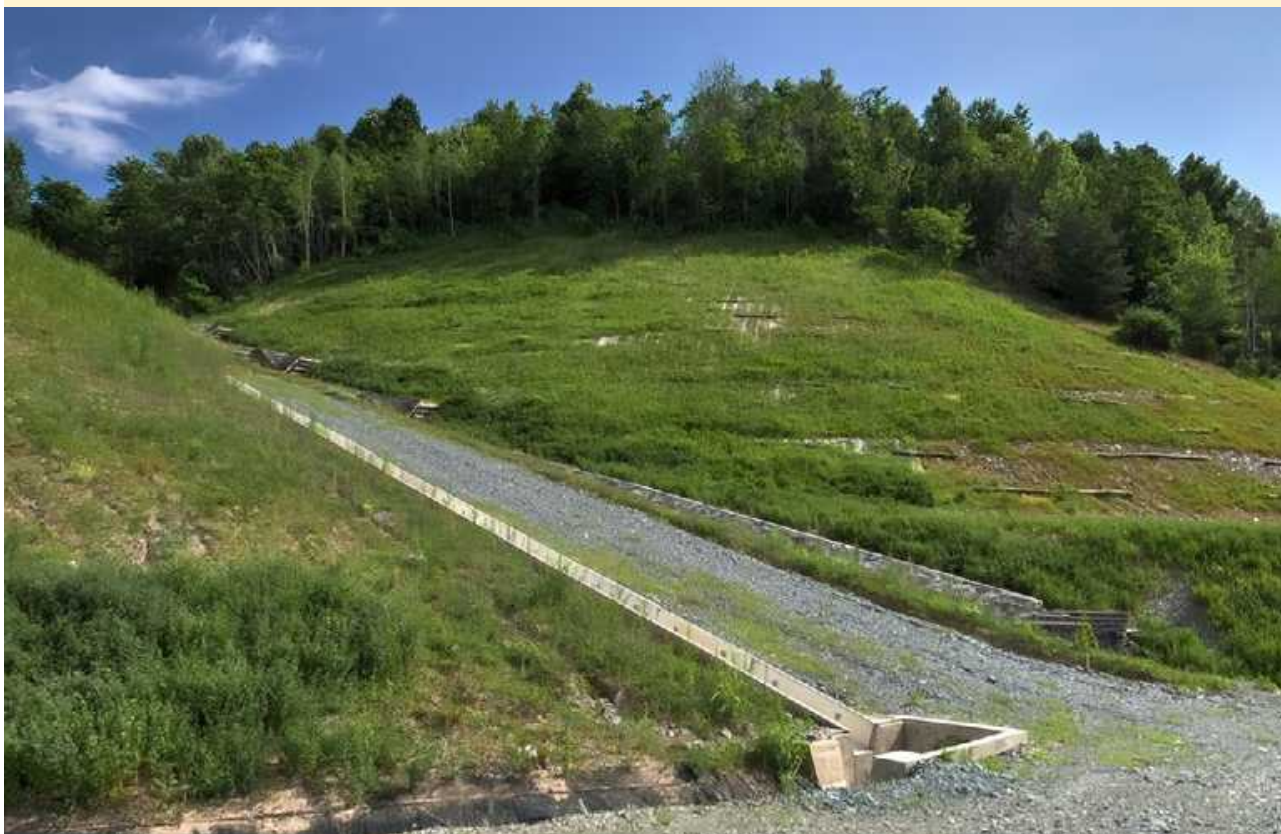
**Figure 15-10: Area A after remediation: stabilised slopes covered in vegetation prevent the release of airborne dust**

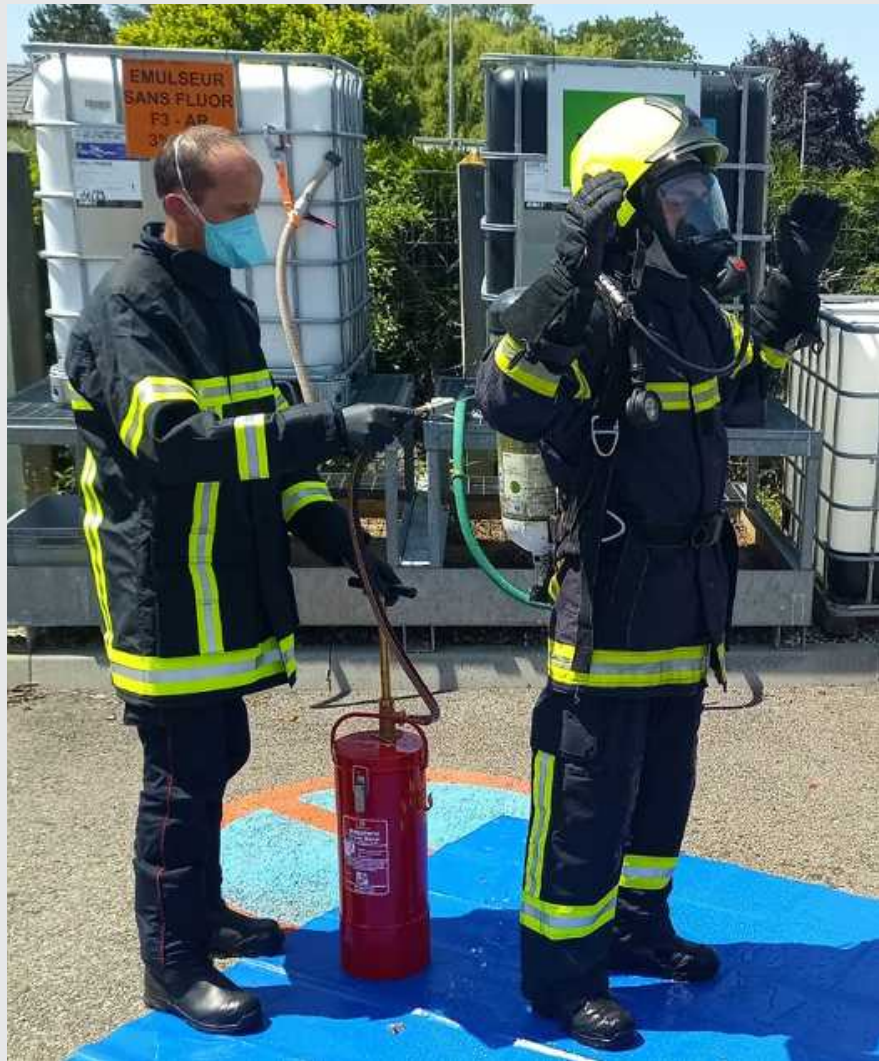
Figure 17-1: A firefighter wearing thermal protective PPE and a self-contained breathing apparatus (SCBA), undergoing the initial stage of asbestos decontamination at the fire site

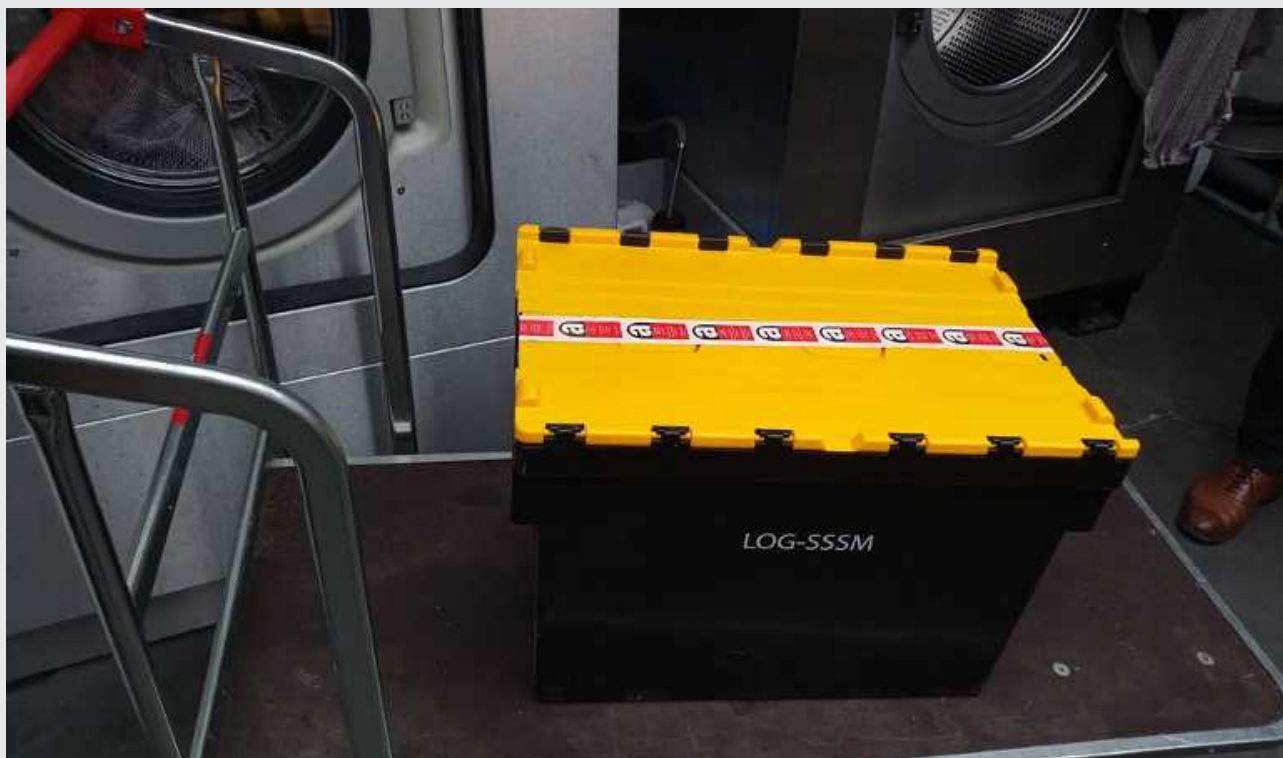
**Figure 17-2: Sealed box containing asbestos-contaminated clothing and equipment for thorough cleaning at the fire station**

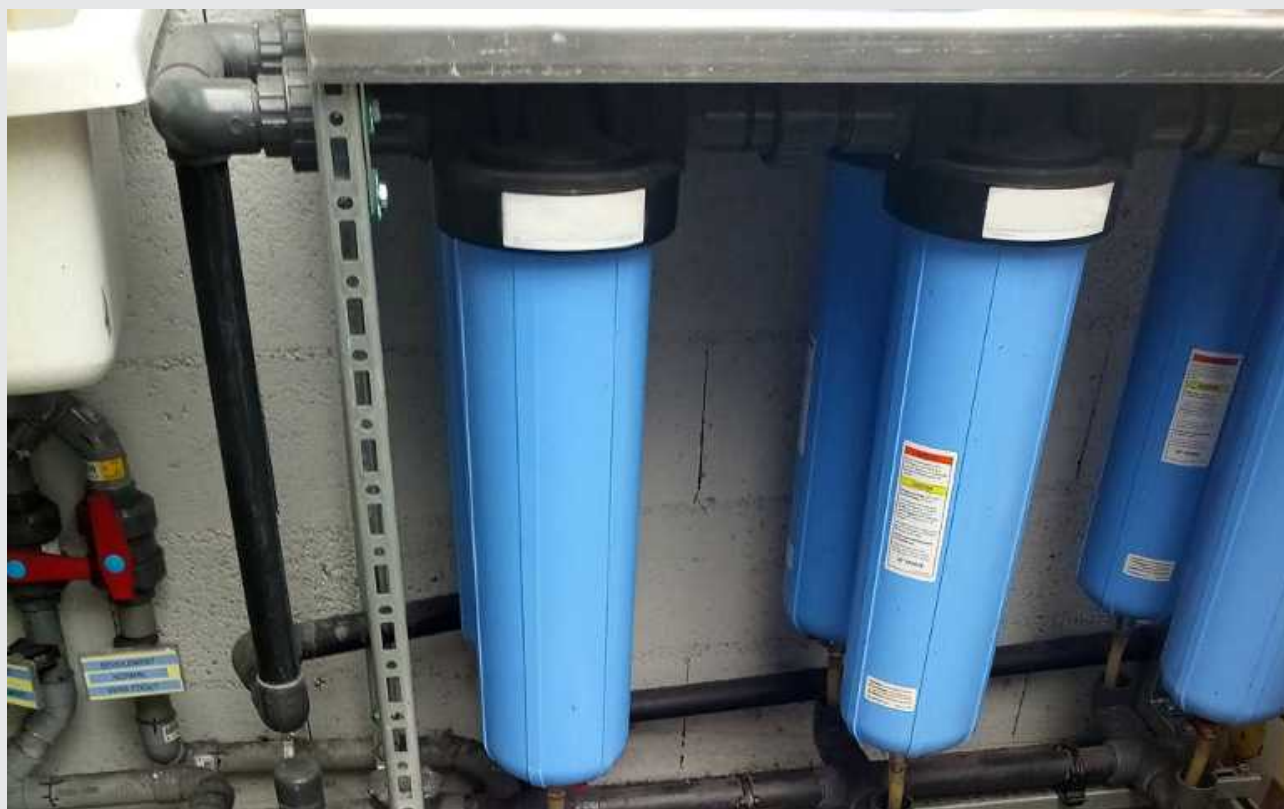
**Figure 17-4: Filters installed in a fire station to remove asbestos fibres from waste water**
